THE HISTORY AND CONSTRUCTION

THE ROSSBURG INN

A THESIS PREPARED

PHI MU HONORARY ENGINEERING FRATERNITY

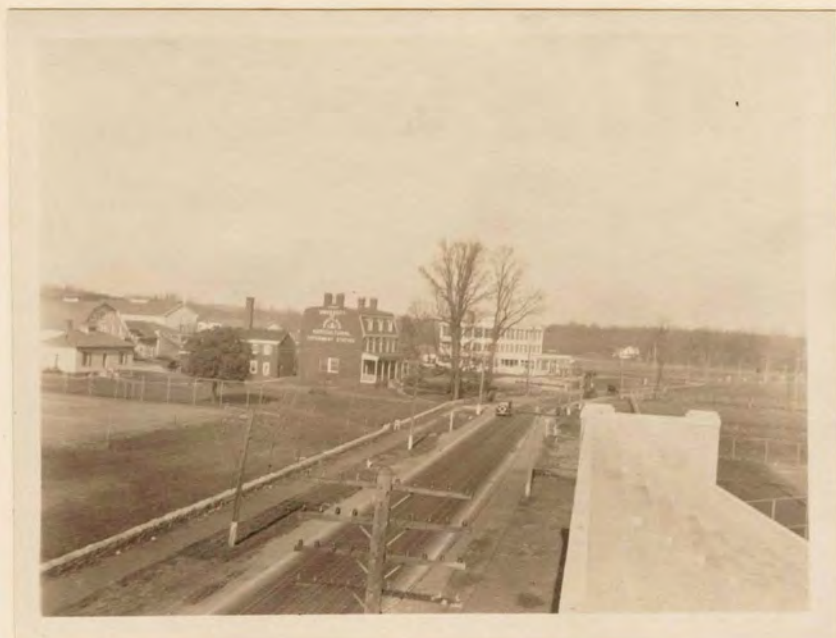
Figure 4

General view looking north showing Agricultural Experiment Station buildings to left and Dairy Building in background. A good idea of the size of the English elms in front of the building can be obtained.

time of establishment the Rossburg Inn was the only building on the tract. The construction of other buildings began in 1857 and the college was formally opened in October 1859. During the early history of the school, the old inn was used as a home for the faculty. Mr. N. B. Worthington, president of the faculty from 1864 to 1867, made his home there. By an Act of Congress for the endowment of an agricultural college in 1862, the college was given funds by the Federal Government. By an Act of 1887, the Agricultural Experiment Station was established and \$15,000 yearly appropriated for the establishment and maintenance of Agricultural Experiment Stations in the United States. This was the first agricultural experiment station established in the United States and in 1892 the station was put under a separate director by the board of trustees. This experiment station is now in the Rossburg Inn, and the name of the station is painted on the building in large white letters. This is well illustrated in figures 3, 4 and 6.

The windows are 2 feet 10 inches by 6 feet on the first and second floors, but on the third floor front they are smaller, and built out to conform to the shape of the roof. This is shown in figures 4 and 5. On the first and second stories of the front,

On reaching the third floor, the first thing that comes into view is a metal arrow suspended from the ceiling in the hall by a metal rod. On examination, it is found that this rod extends up through the roof and is connected to the weather vane on the top of the house, as shown in figure 4. On this floor there are four more fireplaces of the smaller size, and it can be noticed that the chimneys begin to converge so that whereas they were approximately in the center of the rooms by the time they reach the roof they are only about two feet apart. This applies to the chimneys on both the north and south sides of the building as can be seen in figure 4. By referring to figure 6, as well as figure 4, it will be seen that on the south side of the building (figure 6) the windows are between the fireplaces, while on the north side (figure 4) the windows are to the sides of the fireplaces. Only a portion of the rear windows can be seen in figure 4.

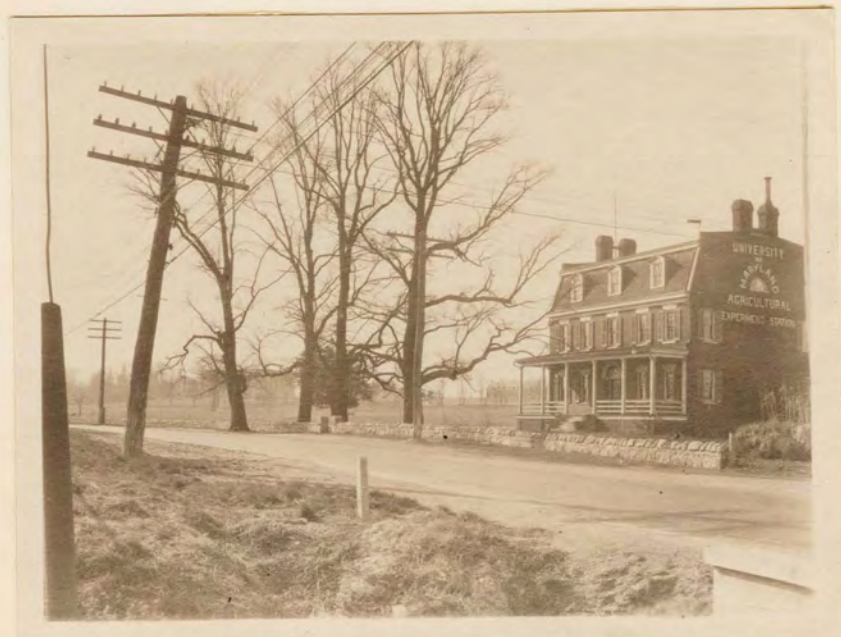
View looking south, showing front and north sides of building. University of Maryland campus in background.

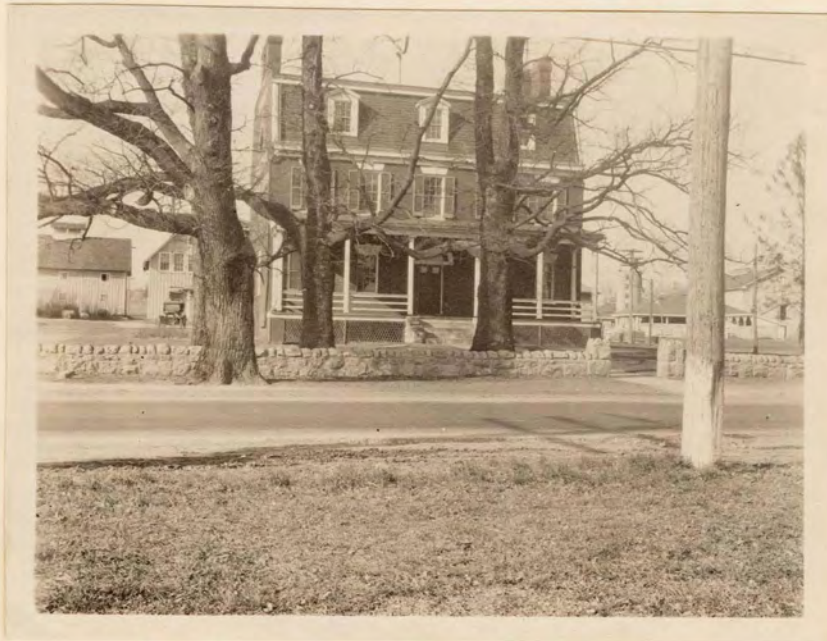
Figure 5

Front view showing English elms and dairy barns of the University of Maryland to right where original stables stood.

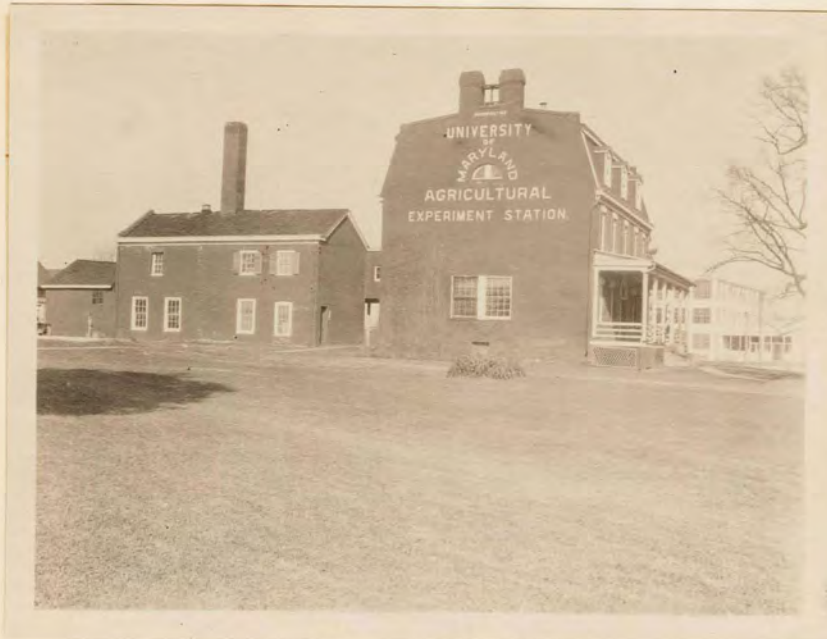
Figure 6

South view showing rear building used for kitchen and well to left.

had they been purposely planted that some of them would have been placed to the right. There is one probable explanation of this, and that is that these trees have been struck by lightning quite often, and it is possible that there were other trees to the right, but they have been killed by having been struck. It is generally known that the trees now standing have been damaged by lightning, one such occurrence having been within the past year. The terrain along the highway in the immediate vicinity is flat and clear, and as the traveler approaches, these four trees, together with the red building, are caught by the eye long before the inn itself is reached. This is fairly well illustrated in figure 3. About 35 feet to the south of the rear part of the building is a well which gives a very good supply of water, and this well has undoubtedly been a source of supply since the erection of the inn. This rear portion was where the cooking was done and together with the well can be seen to the left in figure 6.

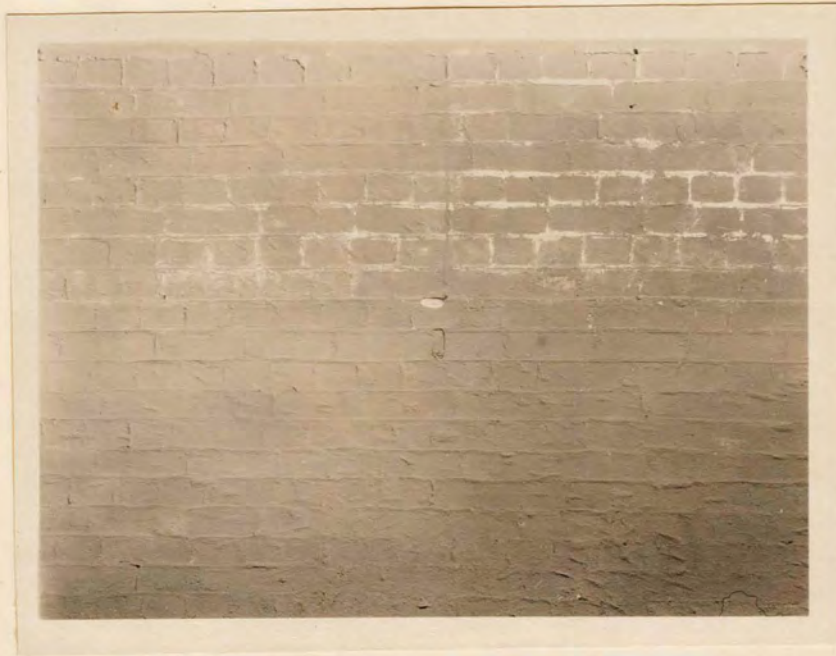
View of section of south wall, showing English system of bonding the brick and stone resting on ledge formed by change from 19 inch wall to 15 inch wall at first story.

two stretchers in the same course, and a course of stretchers every six or eight courses of headers. This is not carried out over the entire front of the building, however, as there will be two headers for every two stretchers in some courses. On the sides of the building, the English system of alternate courses of headers and stretchers predominates, although this system is not carried out throughout the walls. Figure 7 is a section of one of the side walls where the English system was used. In the back of the building there is no definite system at all for more than five or six courses. In general the brickwork is in good condition, although there are a few cracks that have developed over or under the windows. One of these can be faintly seen over the right of the double window in figure 6. The bonding is accomplished by a plain joint about  $3/8$  inches thick, which is about that used for common brick work today.

The foundation is of rubble masonry up to the ground level. From there up to the first story it is a 19 inch brick wall and from the first story up to the roof, the wall is decreased to 15 inches. Figure 7 shows where the wall changes from 19 inches to 15 inches. The stone in the center of the picture is resting on the 2 inch ledge caused by the change in the thickness. The remaining 2 inches is taken care of on the inside of the wall.

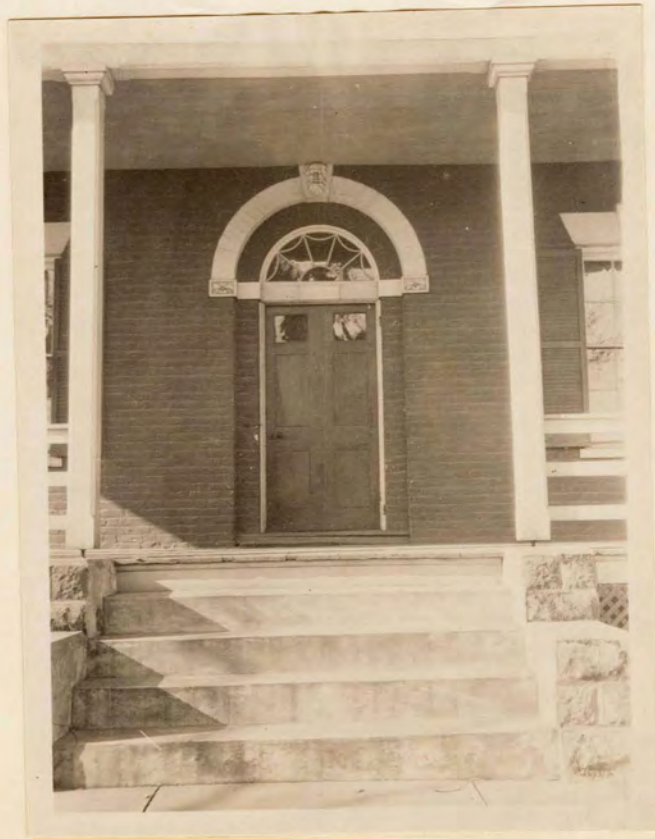
Figure 8

View of main door, showing arch and keystone.

The main door is in the center of the building and is 3 feet 6 inches by 7 feet. This door has a joint running its entire height in the center, which gives it the appearance of being two narrow doors being made into one. Near the top are two small glass windows 10 inches by 12 inches, and in the lower left hand corner there can be seen a patch  $3\frac{1}{2}$  inches by 4 inches which has been put in since the door was made. Originally there was a hole in the door to allow the family cat to pass in and out at will. This was the practice during the period when the building was constructed. The knob is on the left hand side of the door as you enter, while the general practice today is to have the knob on the right hand side. The door sill is made of wood, the same as the window sills. The door is shown in figure 8. Above the door there is a semi-circular brick arch having a radius of 30 inches, and a keystone 13 inches deep, and varying from 14 inches wide at the bottom to about 8 inches at the top. This keystone has the following inscription on the bottom of it.

T. Coade, London  
1798

On the face of the stone there is carved the head of a man. The arch and keystone can both be seen in figure 8.

it would seem that a porch was built originally to properly set off the building. There are four concrete steps leading from the porch to the ground with concrete blocks on the sides of the steps. These can be seen in figure 8.
